Case Histories

Down in the Dumps Workshop Notes

Rio Nuevo North

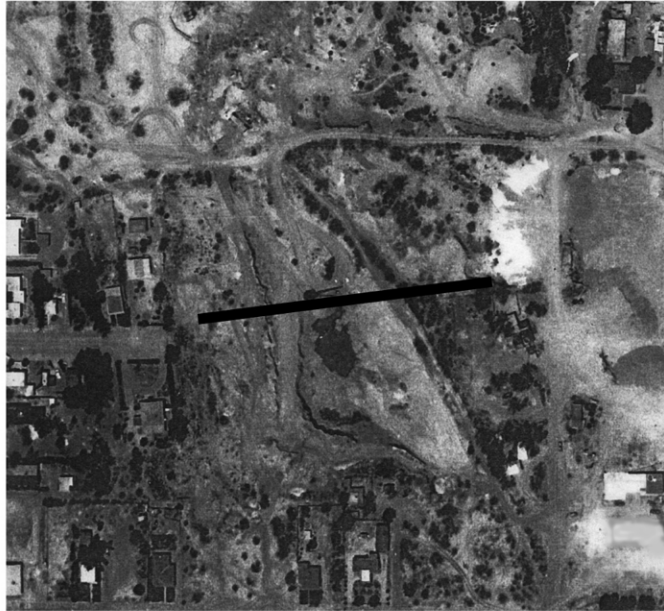
Area photograph from 1953

The location of the test line on the Rio Nuevo North project area was picked to cross a deep pit shown on the old aerial photographs. If garbage was still buried on the property, then the deep pit was thought to be the best location to try and detect the waste.
